# FLIGHT TEST EVALUATION OF OH-58A TAILBOOM FAILURE DURING AUTOROTATION LANDINGS

Thomas L. Sanders  
BELL HELICOPTER COMPANY  
Post Office Box 482  
Fort Worth Texas 76101

14 March 1973  
Final Report

REPORT No. 206-194-134

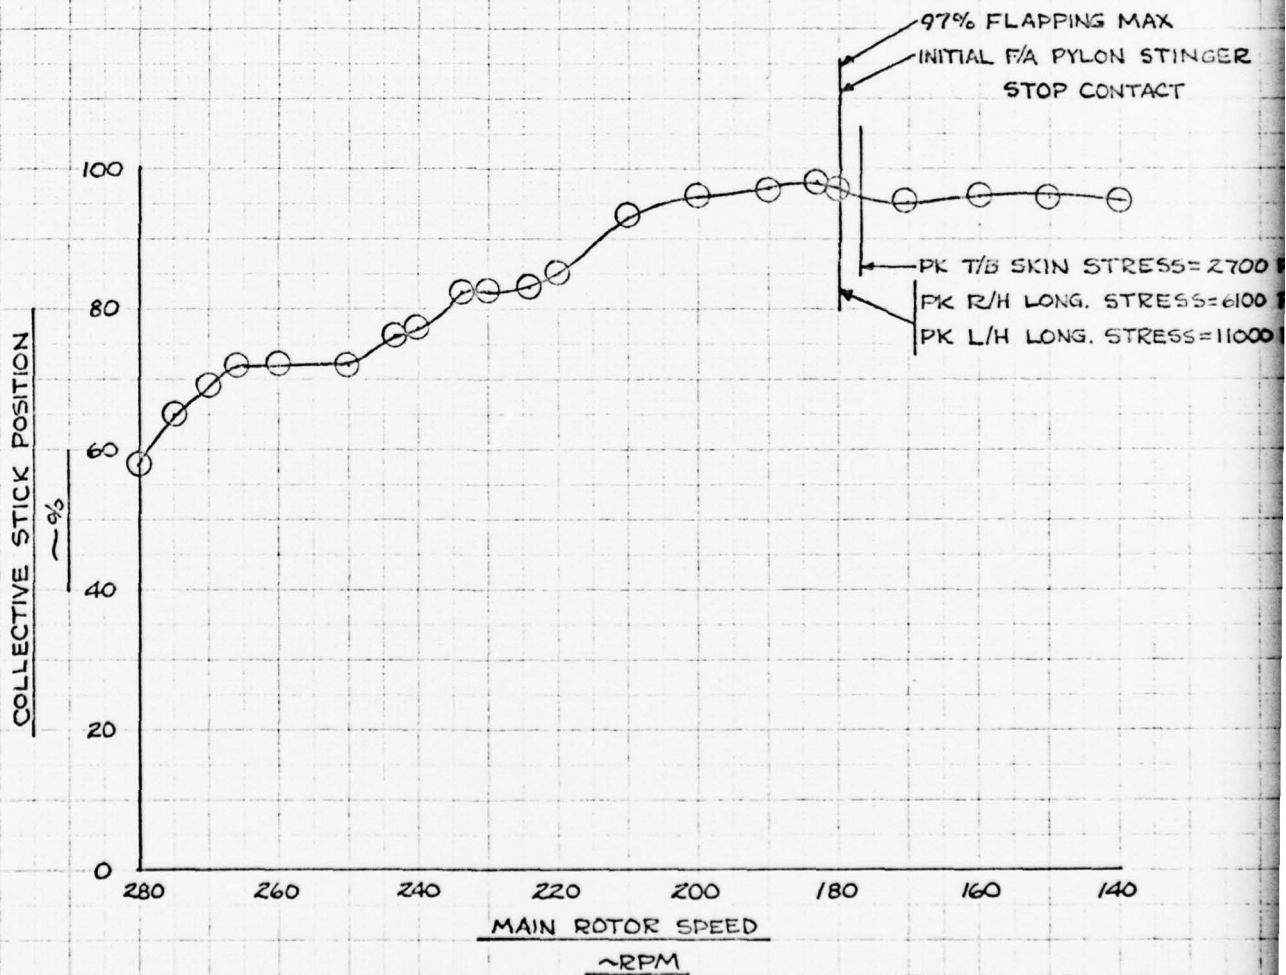
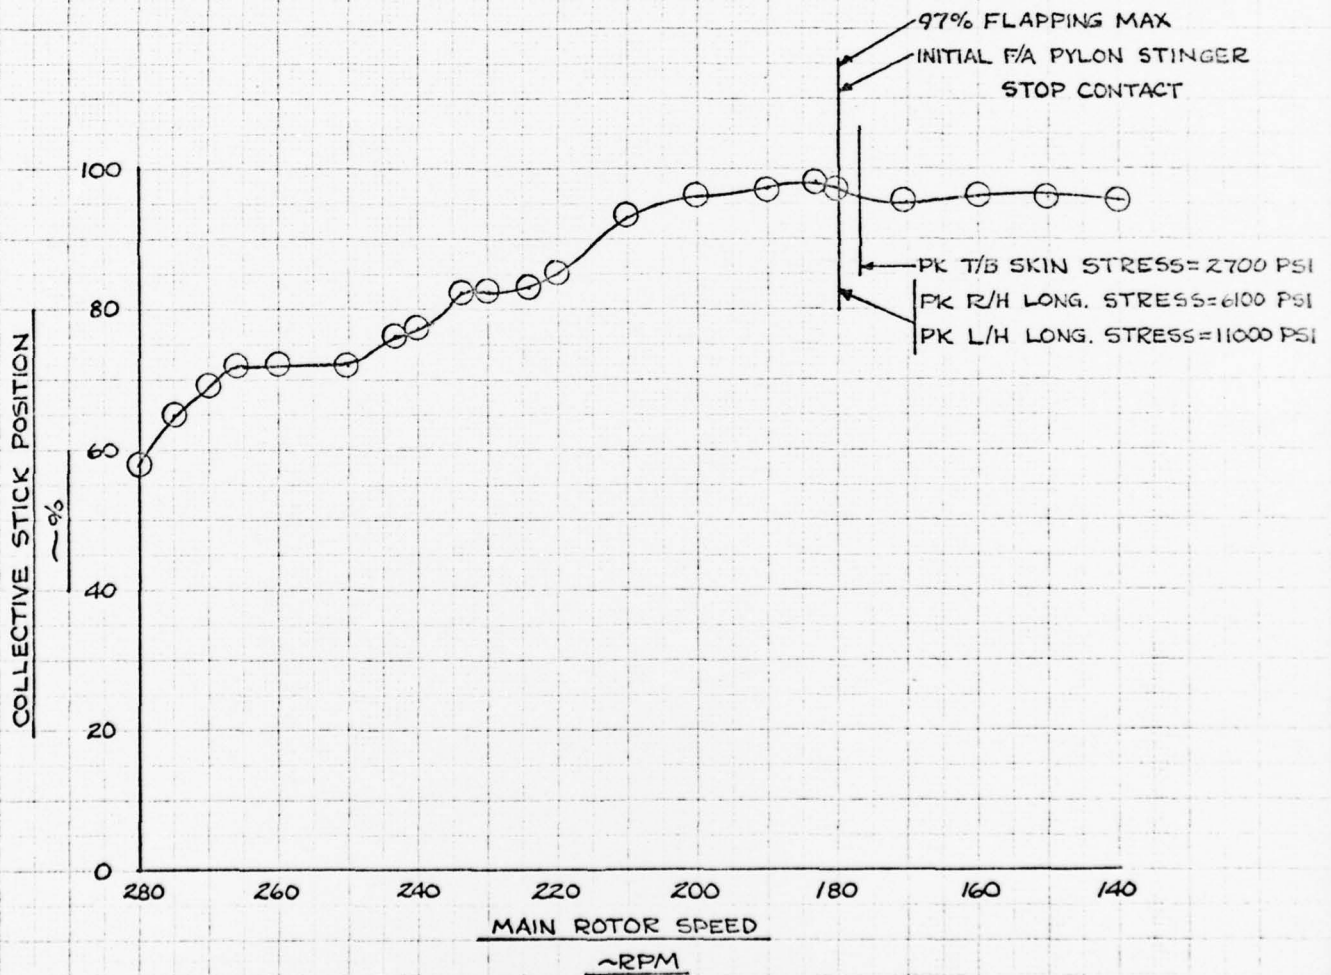
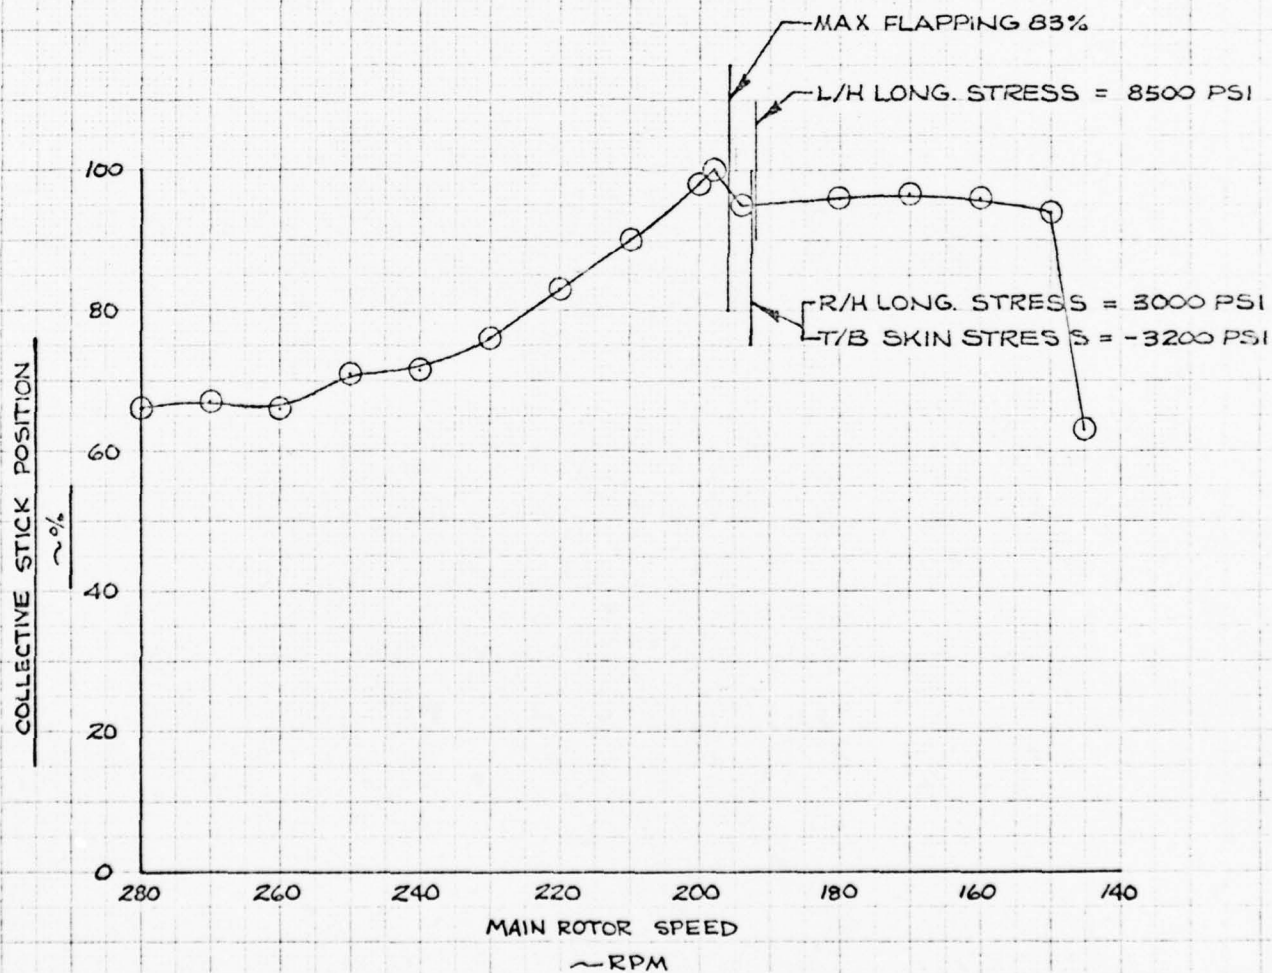
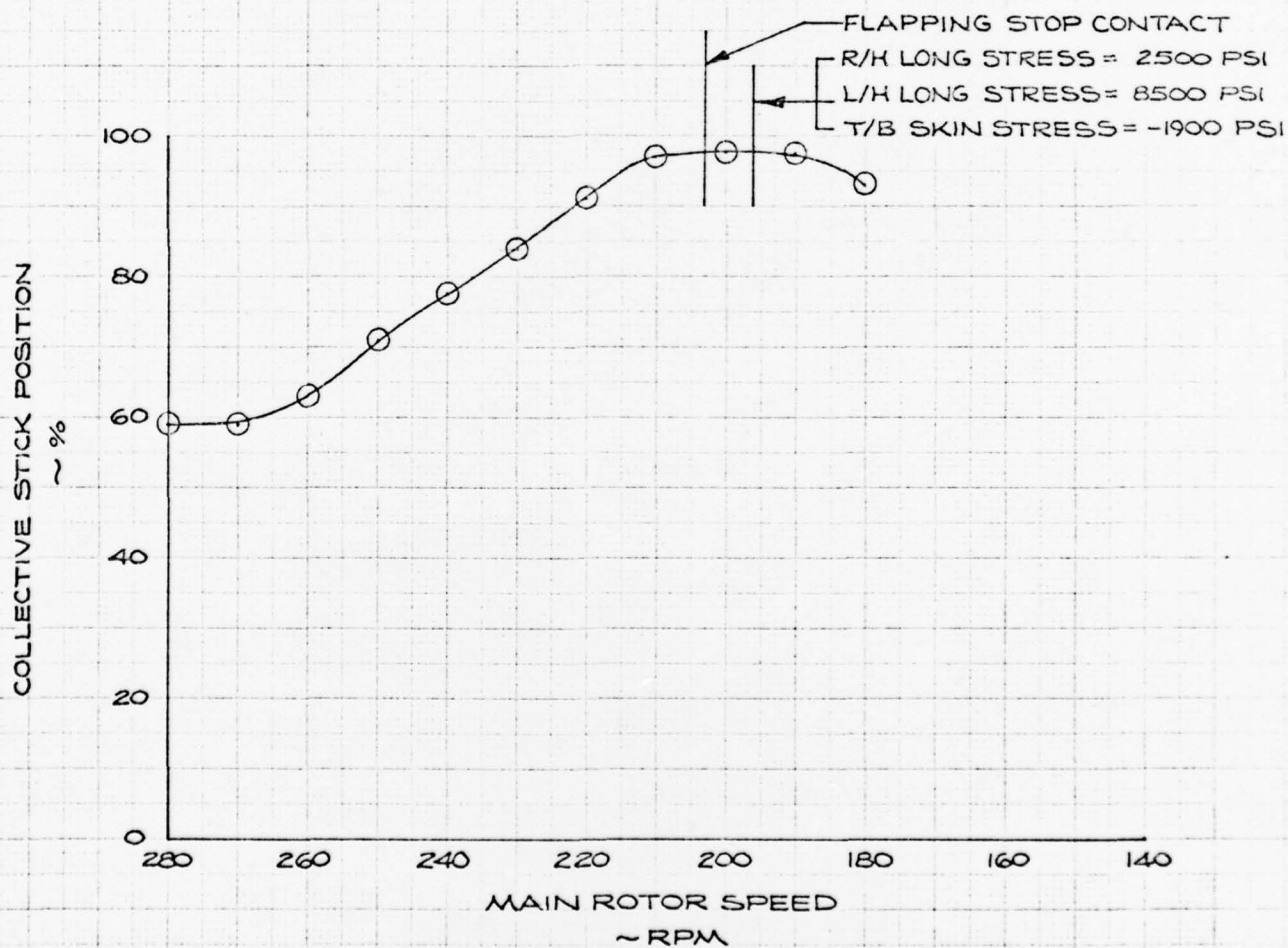
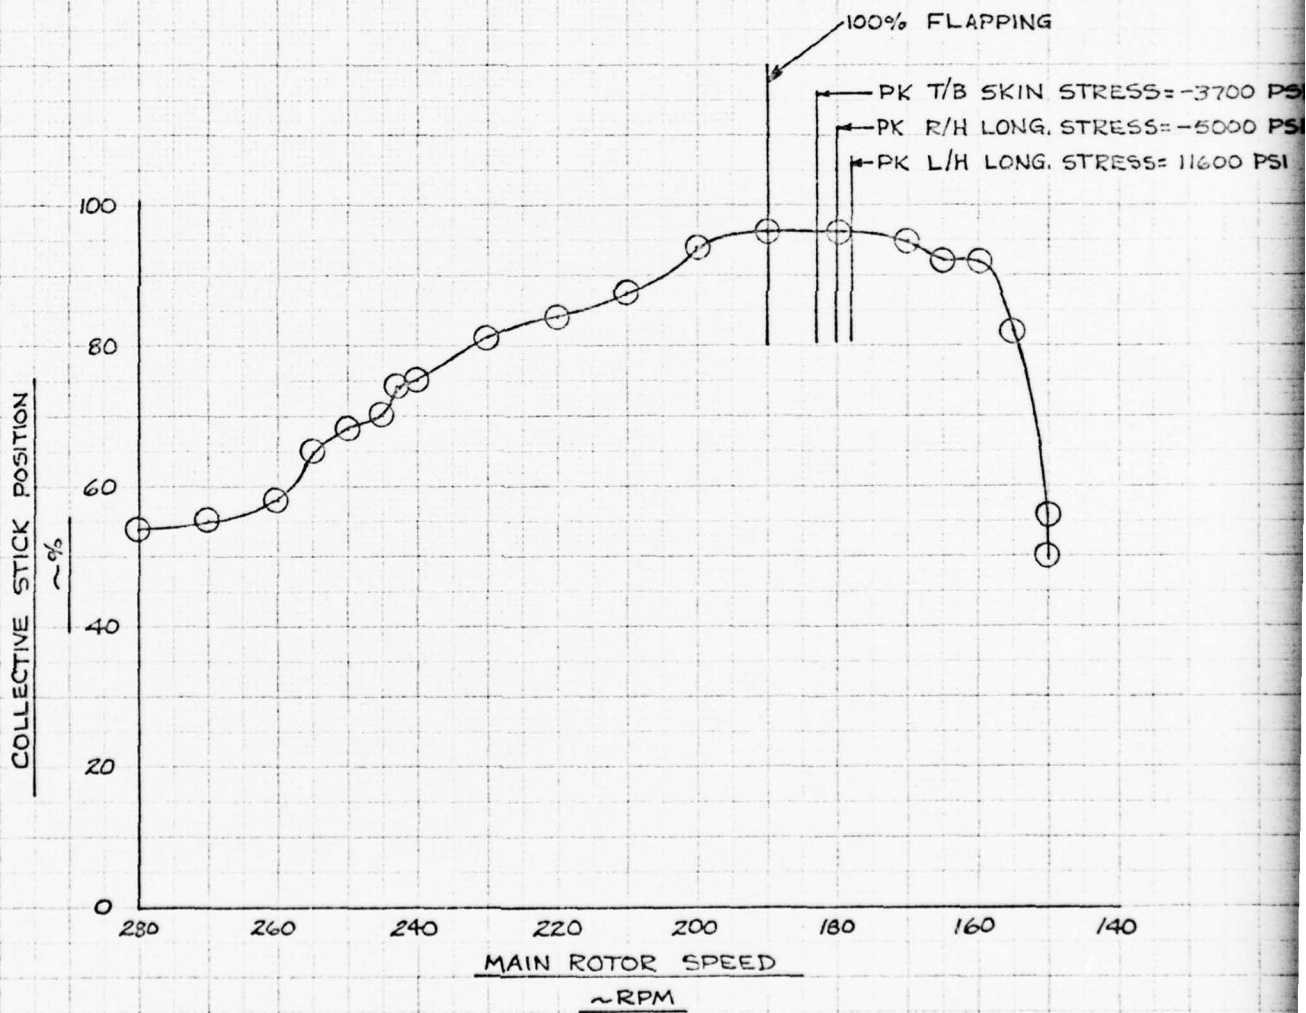
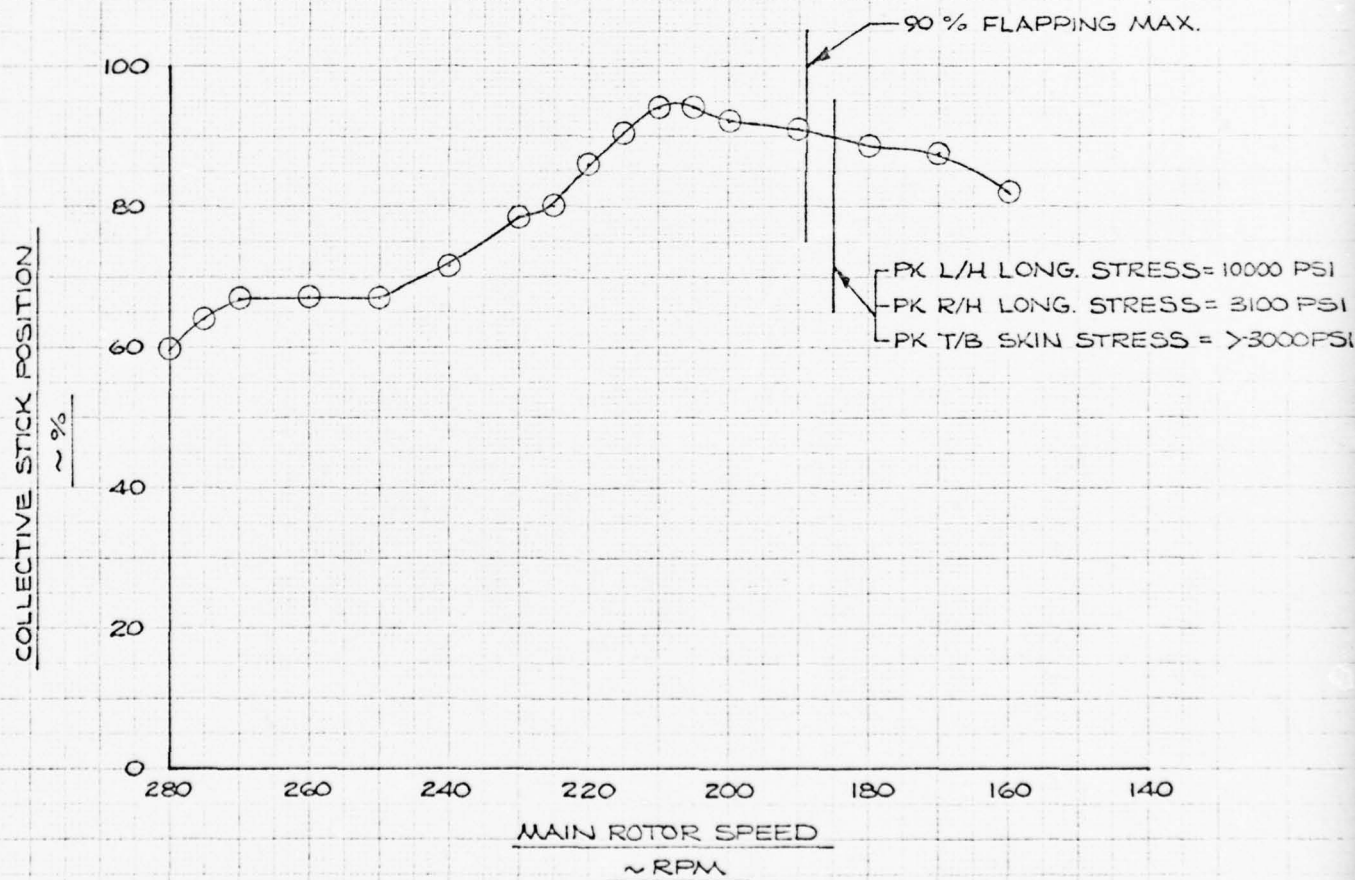
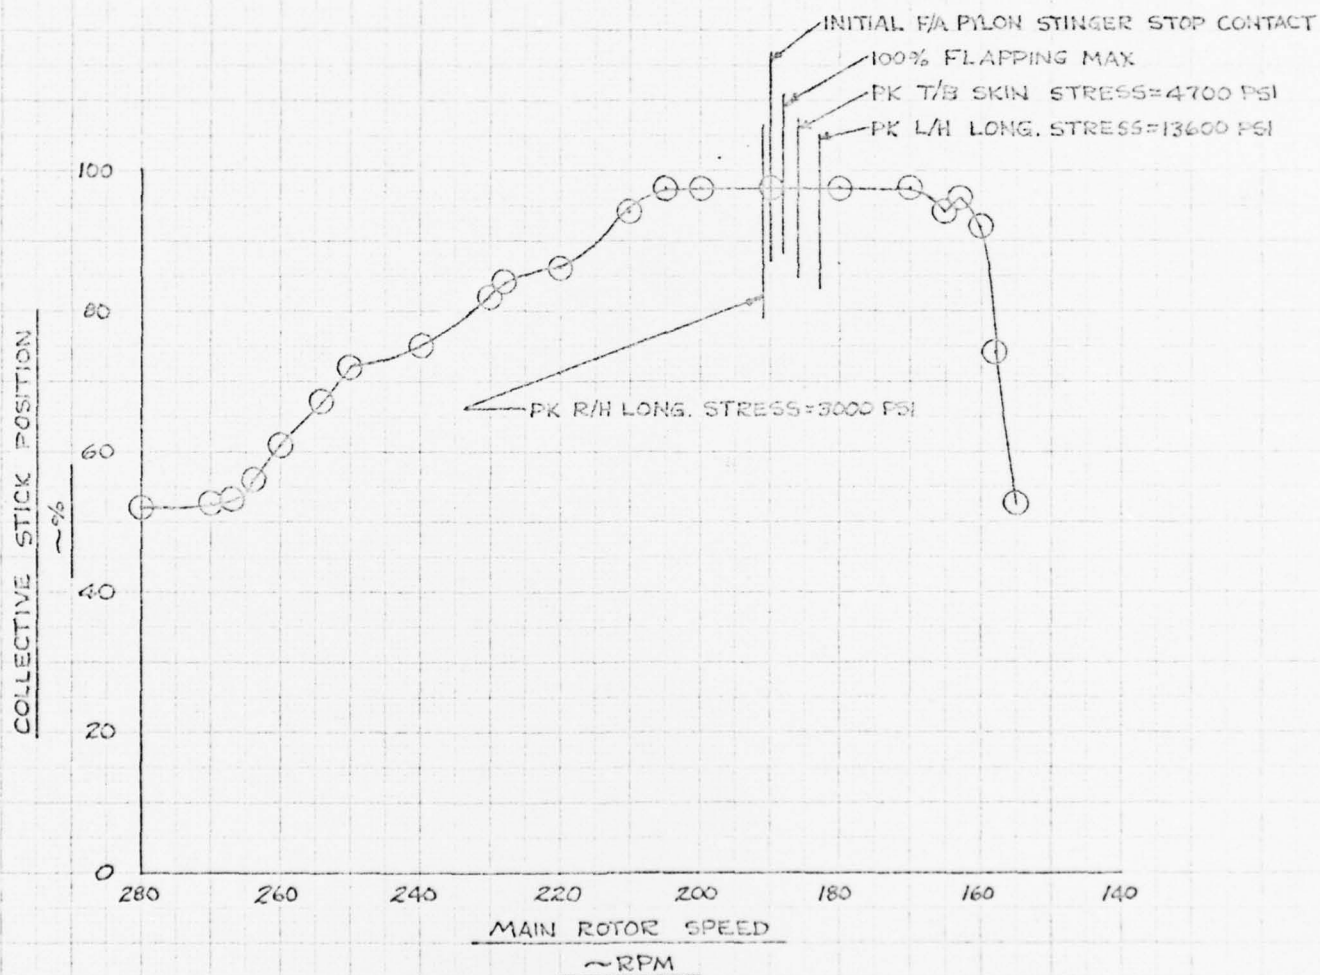
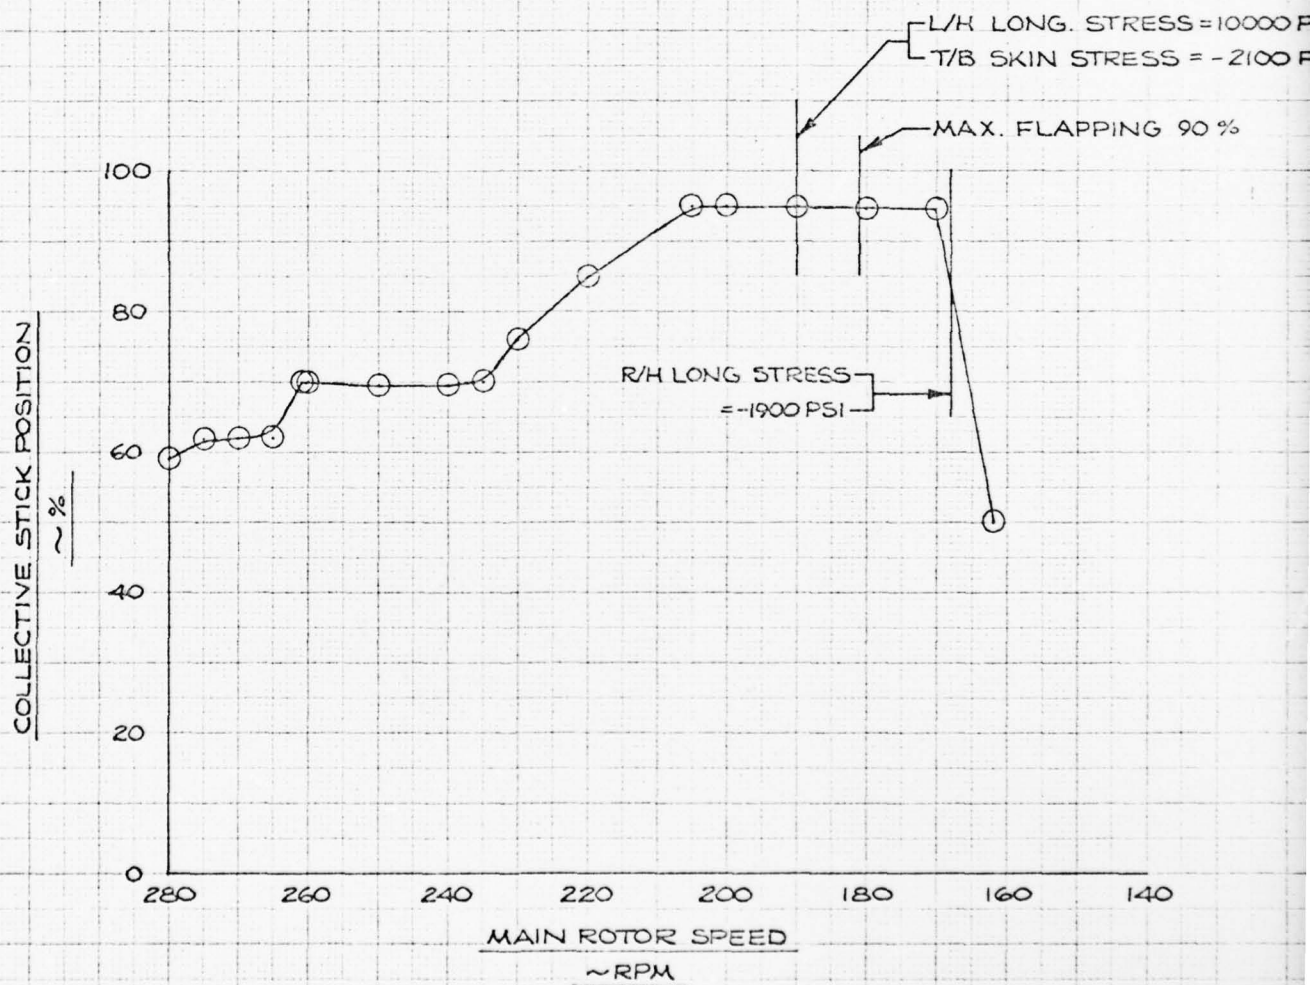
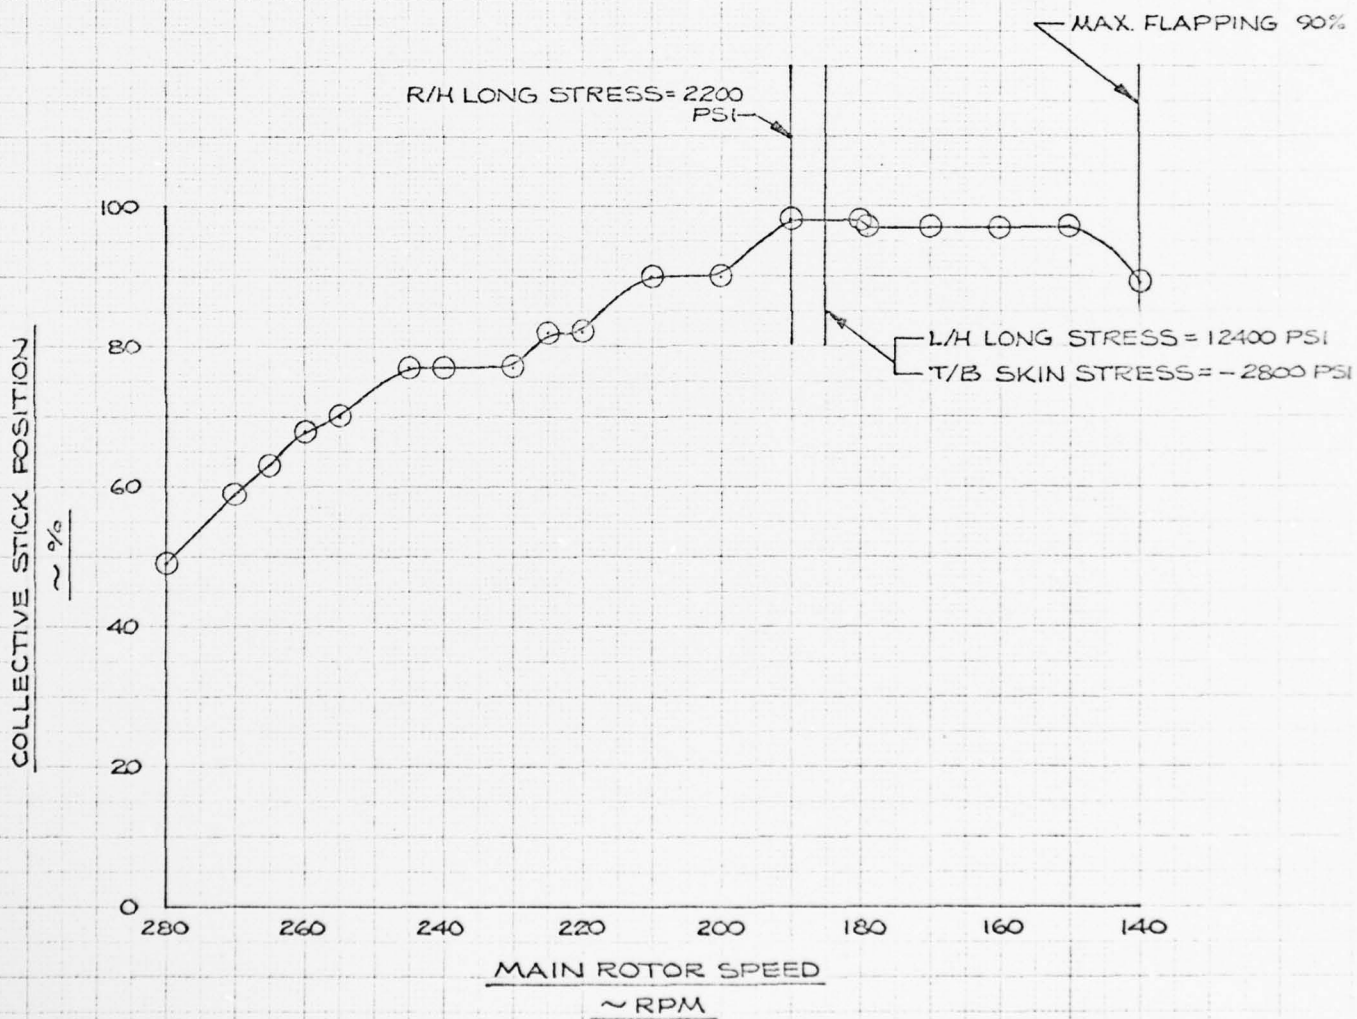
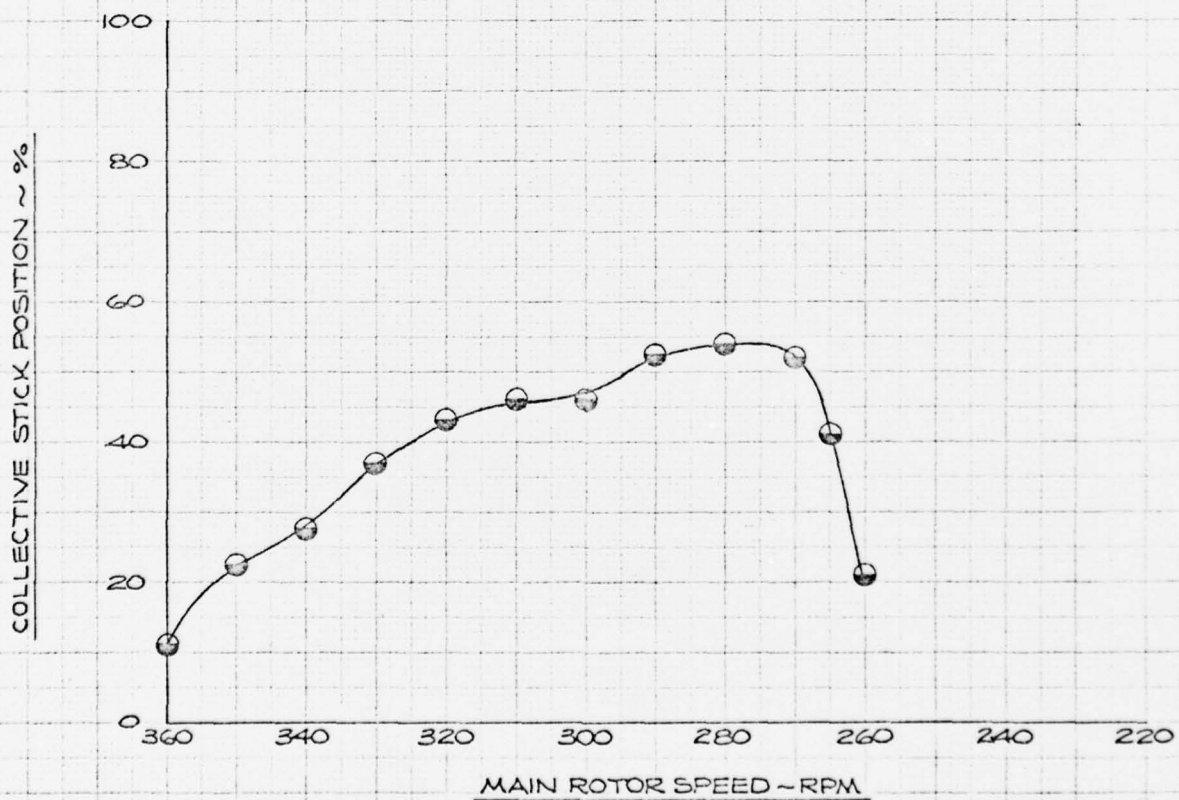
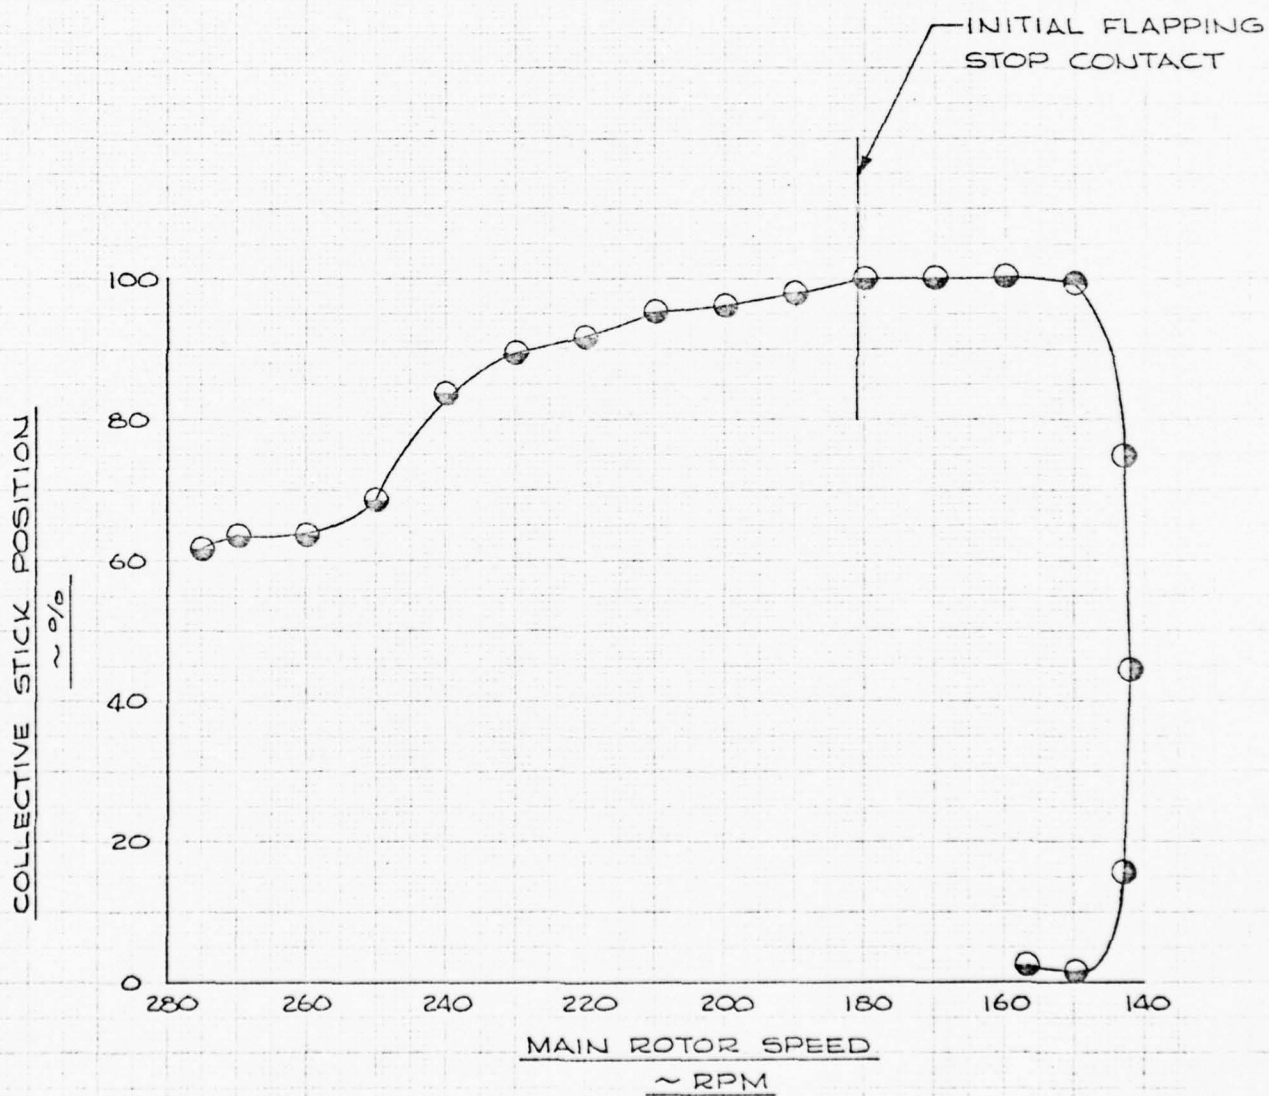
A total of 36 touchdown autorotation landings and 10 throttle chops were flown to obtain data. Analysis of autorotation data began to suggest certain trends of maximum main rotor flapping with high touchdown airspeeds at low main rotor speeds of 200 rpm or less, see Figures 1 through 10. During the third flight, a tailboom failure was duplicated to study the influential circumstances associated with the failure.

Results of this test indicate that autorotation touchdown airspeeds in excess of 30 knots should be avoided and upon ground contact the collective should be smoothly reduced as soon as touchdown conditions permit. Also, tests conducted with the collective range reduced by approximately 20 percent showed a substantial reduction in main rotor flapping and pylon behavior.
